# Assembly and First Training of the Dipole Magnet FRESCA2

29/03/2017

E. Rochepault

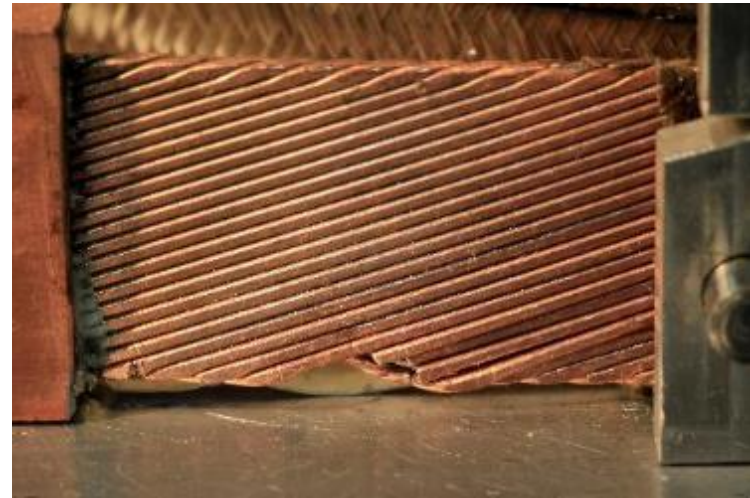
- **Strands damaged** during the splicing operation
- **Additional Cu stabilizer soldered on the damaged area**

- Superficial bubbles due to some air trapped in the pole cavity
- **Local injections of resin**
- **Electrical tests passed**

- Coil CR3401: **superficial bubbles**
  - Air trapped in the pole cavity
  - **Local injections of resin**
  - **Next outer coils impregnated with fillers** placed in the cavity

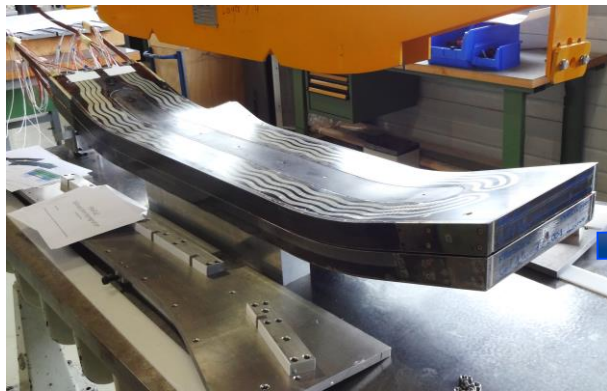
1. Tailored shim assembly x2

- 1 inner coil and 1 outer coil = half a dipole magnet
- Pole-to-pole contact:
  - Reference for assembly
  - Transmission of vertical pre-load
  - Electrical insulation → 125  $\mu\text{m}$  kapton foil
- Injection of charged resin MY750
- Goals of the tailored shim:
  - Fill the gap between 2 coils
  - Adapt to the gap variations
  - Provide a soft mechanical support
  - Provide an electrical insulation
- After dimensional control analysis, geometry more favourable with:
  - CR1201+CR3402
  - CR1202+CR3401

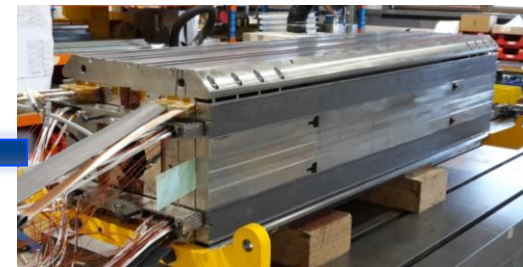
4. Coil-pack assembly

- Positioning of wedges and shims
- Good contact in the mid-plane
- Good electrical insulation

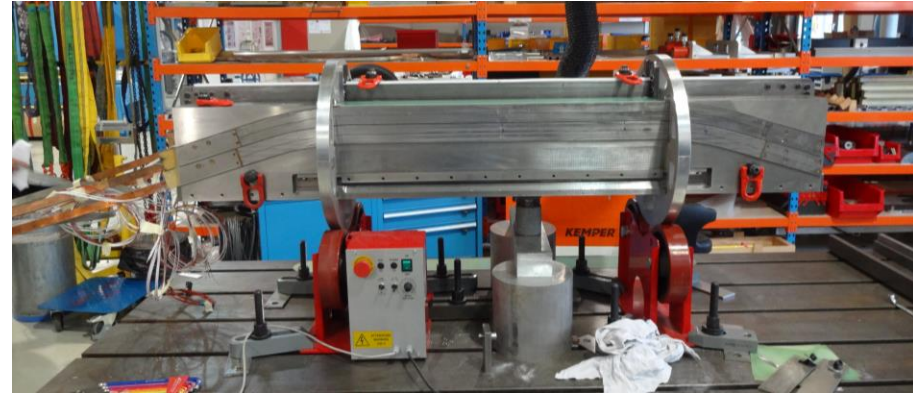
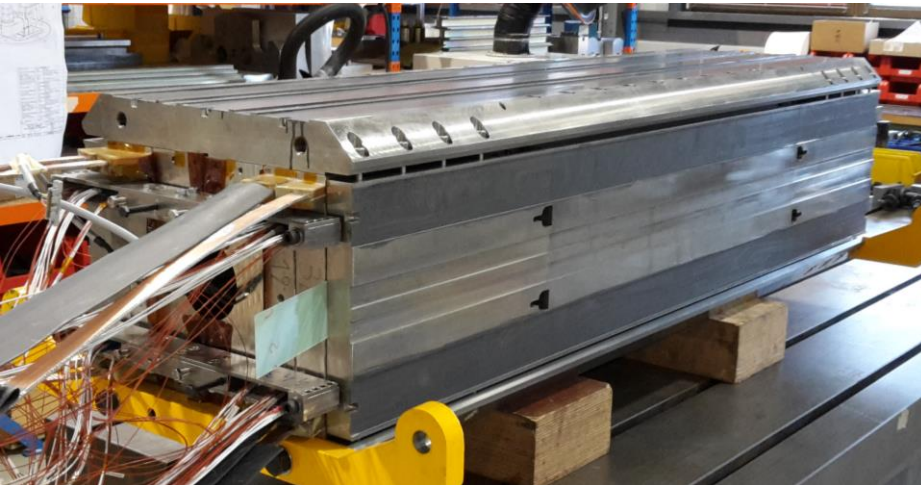
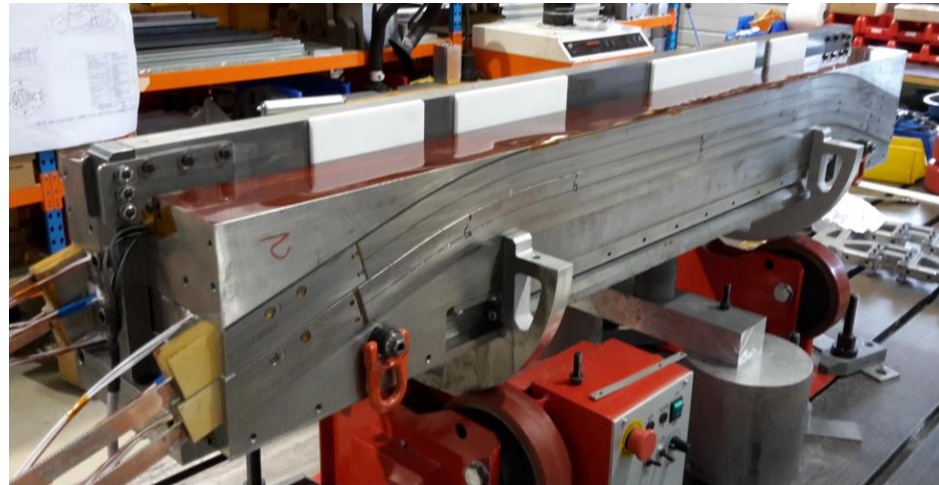
# Coil pack assembly

Shorts coil-post  $\rightarrow$  posts need to be insulated

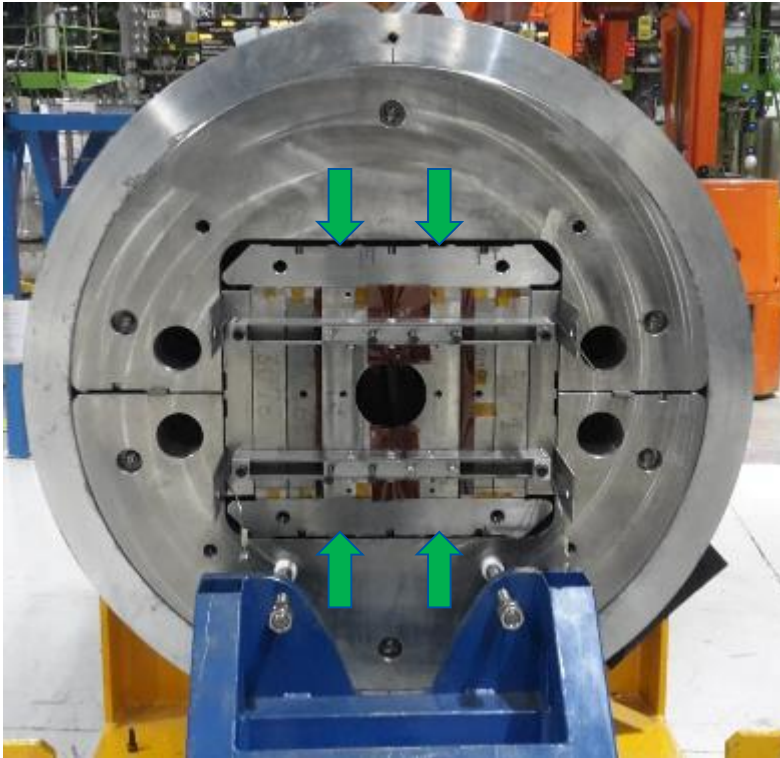
Transverse loading  
bladders & keys

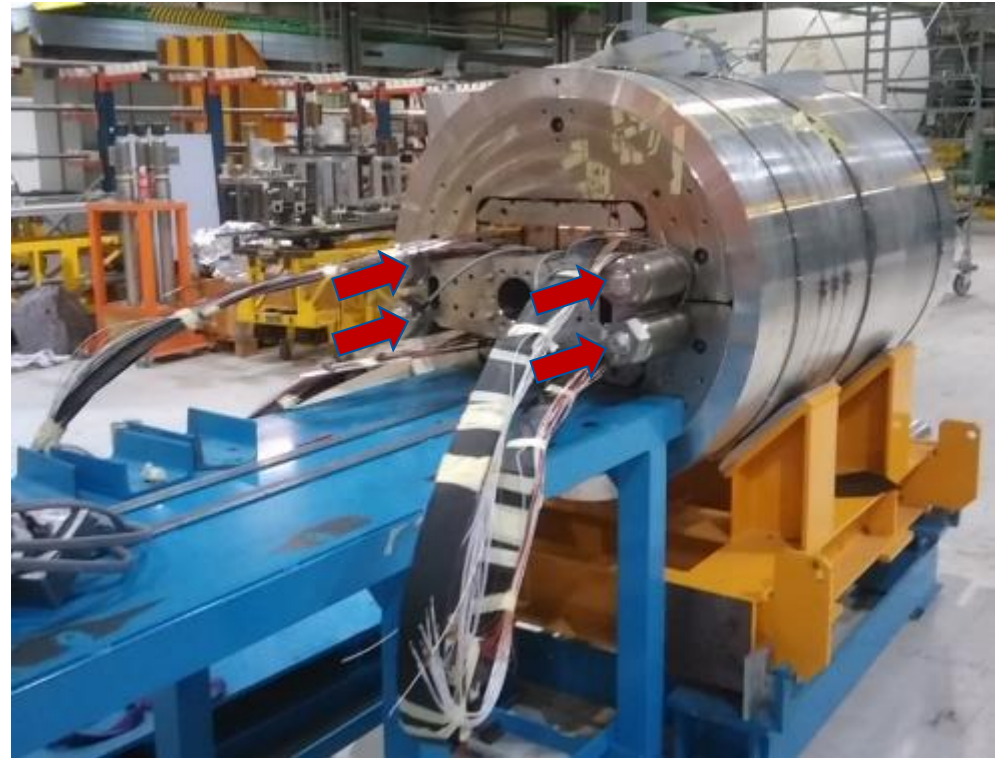
Longitudinal loading  
piston & rods

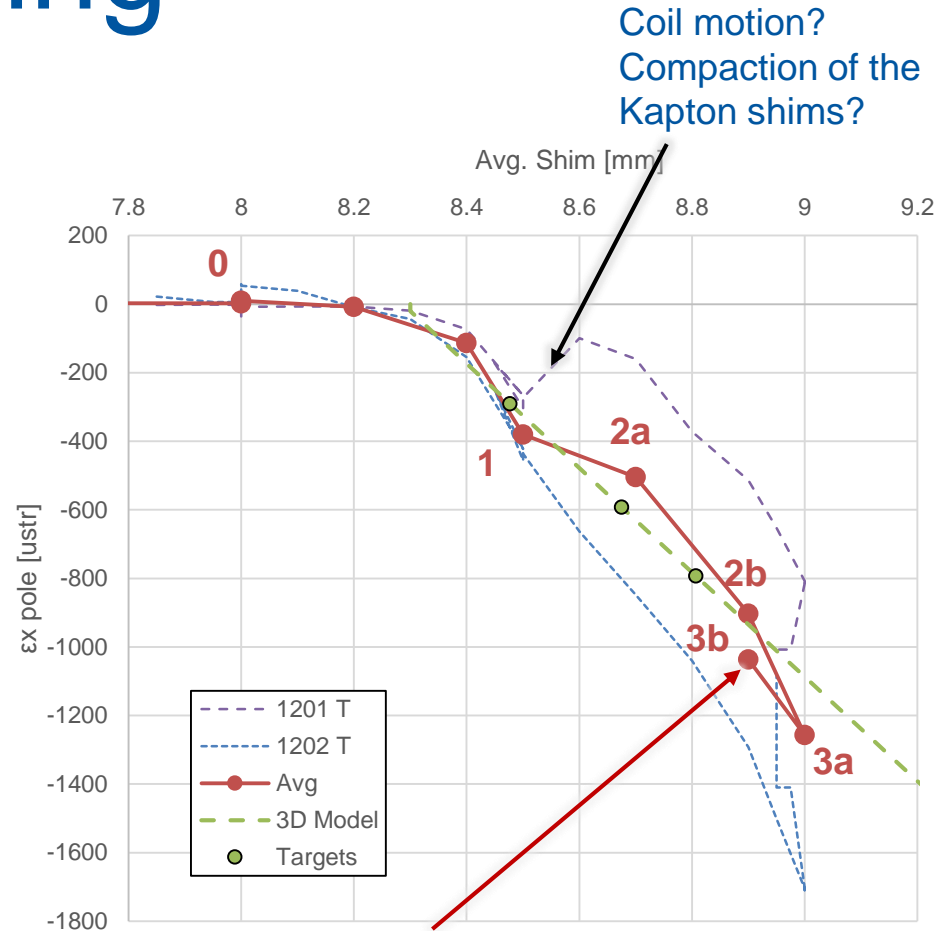
3b: asymmetric loading  
 9.0 mm on 1201  
 8.9 mm on 1202

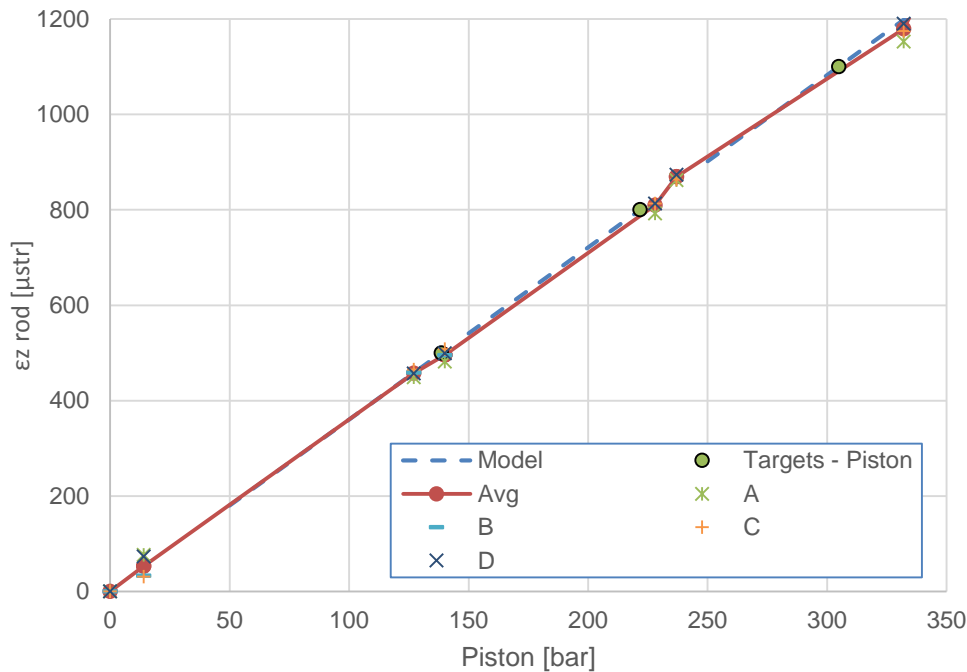
During Piston

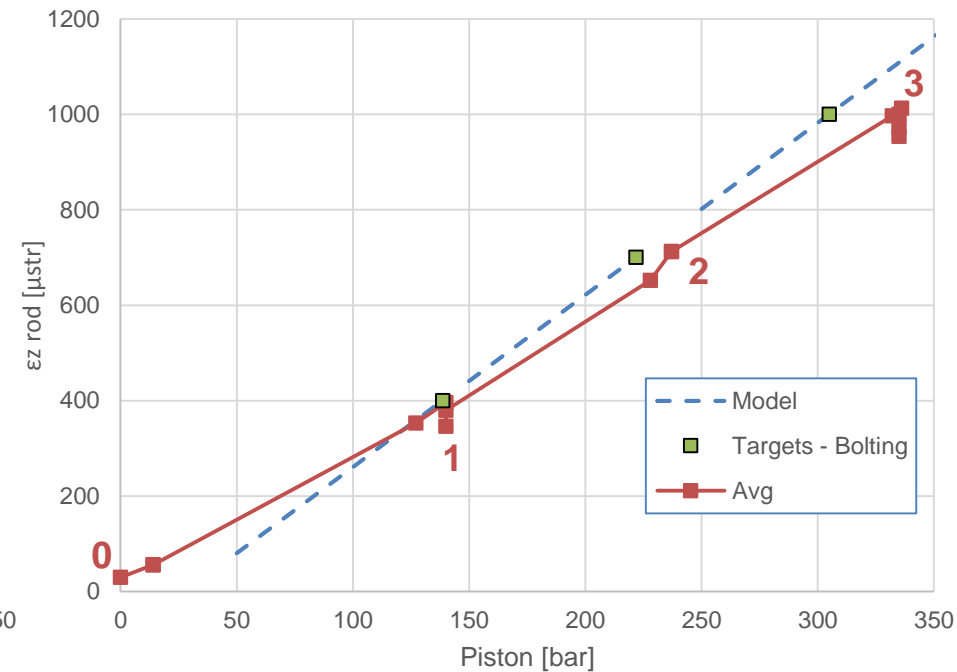
After bolting

→ Very close comparison with the model

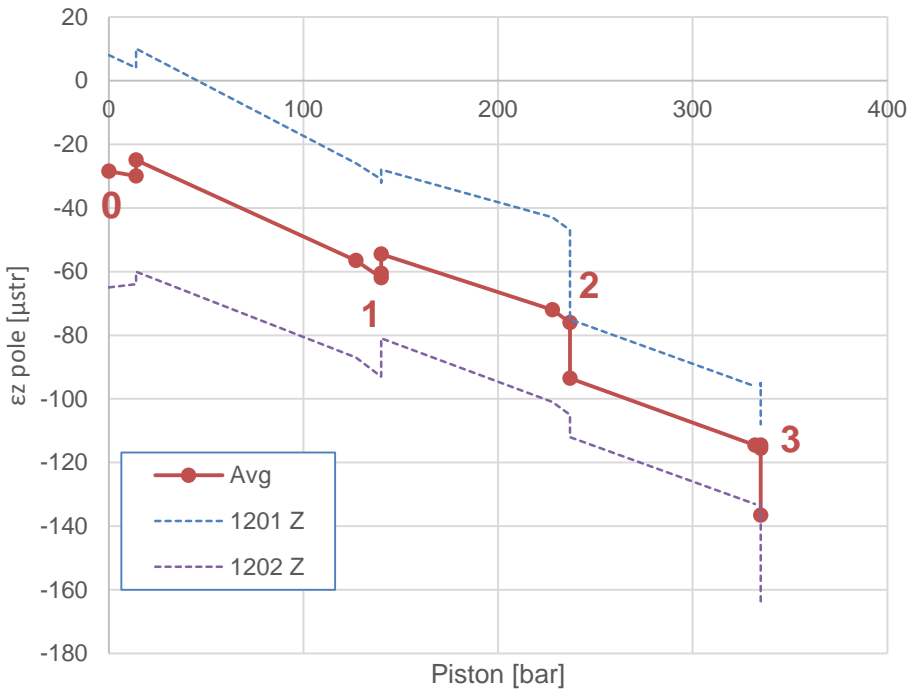
→ The coil is slightly pre-loaded longitudinally

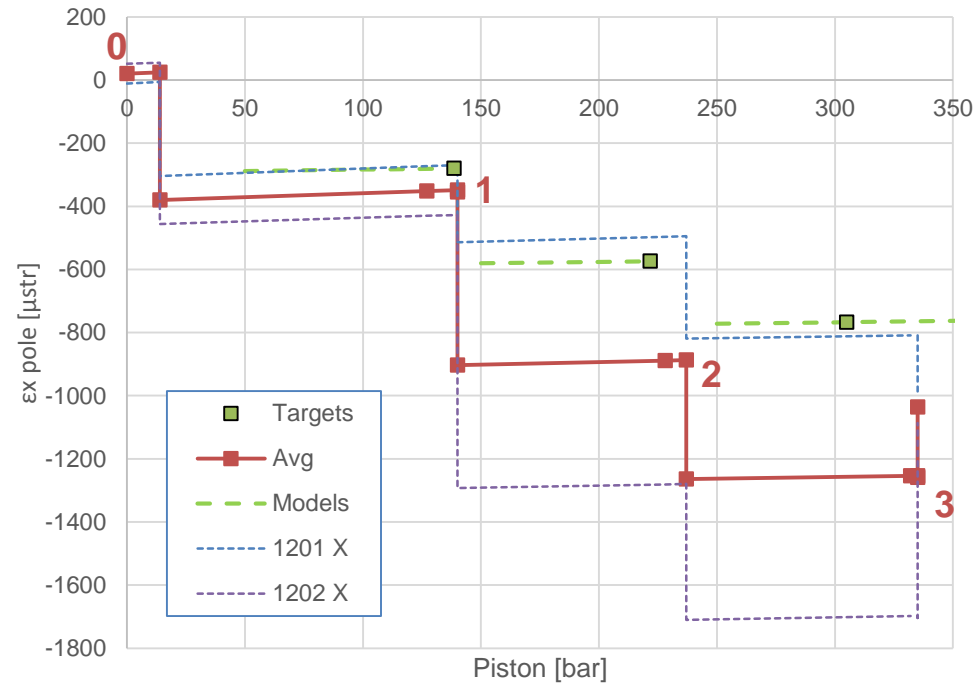
→ Small impact of longi. Pre-load on the transv. Pre-load (+10μstr)

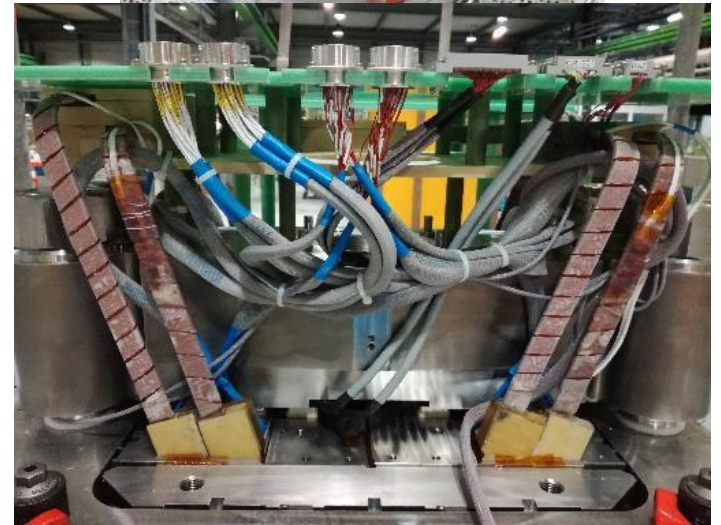
# Interconnections/Instrumentation

- Splicing the leads
- Connection of instrumentation
- Final electrical acceptance tests of the magnet
  - High potential
  - Coil discharge
  - QH discharge

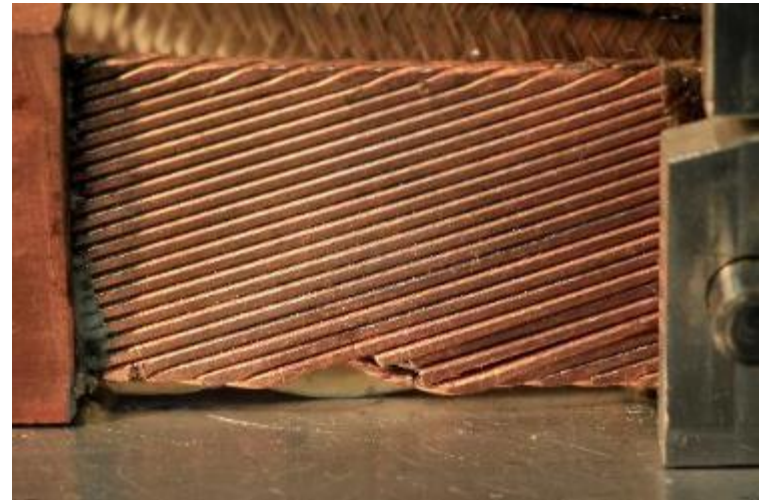
- Splice resistance  $\sim 1 \text{ n}\Omega$   
(other splices  $\sim 0.25 \text{ n}\Omega$ )
- Instabilities when holding current at 6 kA
  - Drift (decay)  $\rightarrow$  current redistribution?
  - Spikes  $\rightarrow$  flux jumps?

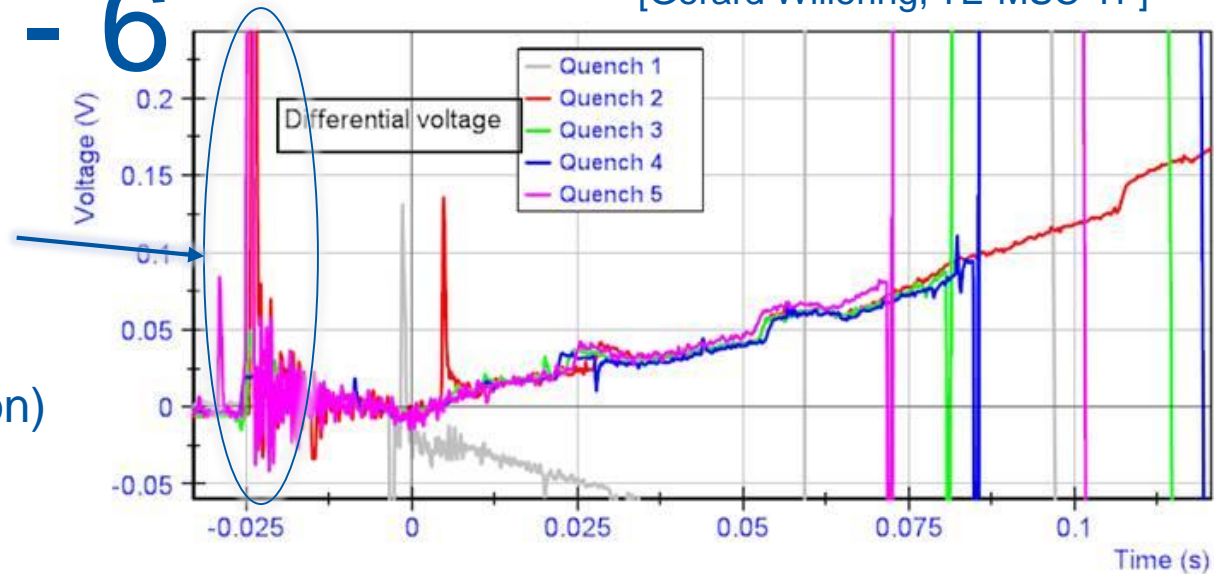
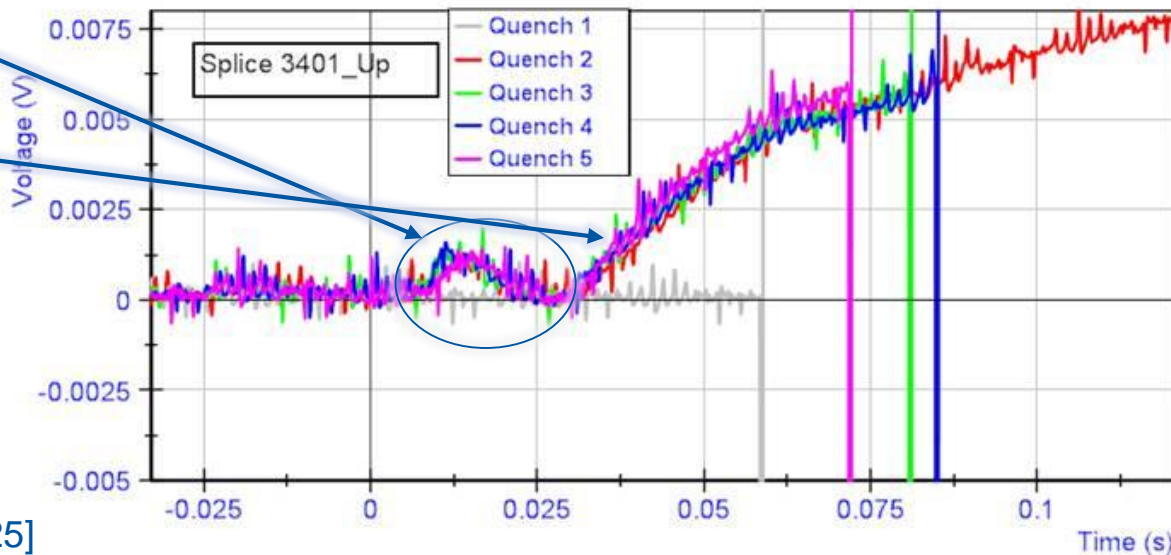
Reproducible pattern:

1. Precursor 25 ms before the quench  
→ 2 and 6 show strong perturbation (possibly motion)

2. Quench starts ( $t = 0$ )

3. Perturbation in the splice

4. Quench in the splice

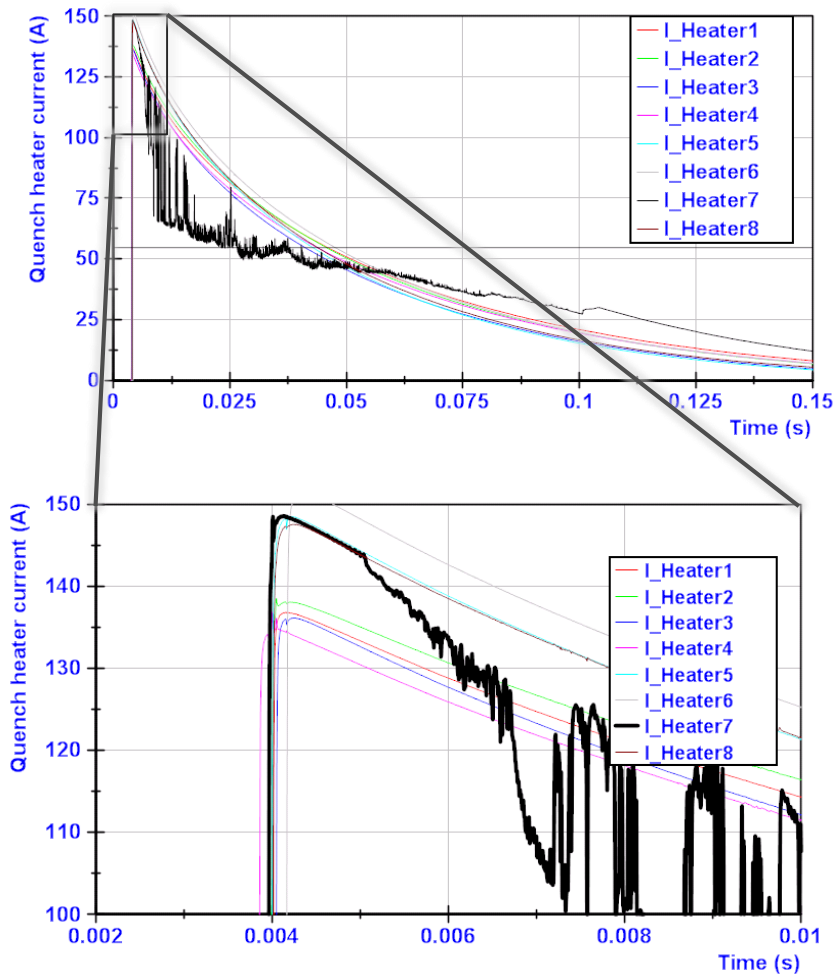
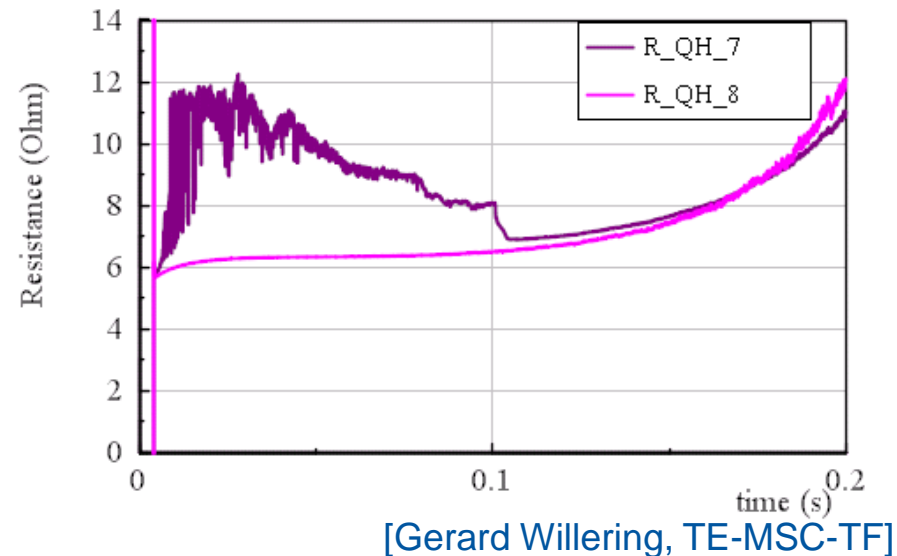
- At the ramp after quench 6 the protection tripped.
- 1 ms after heater discharge start the heater circuit failed.
- In all previous discharges no anomalies, no precursor for failure.

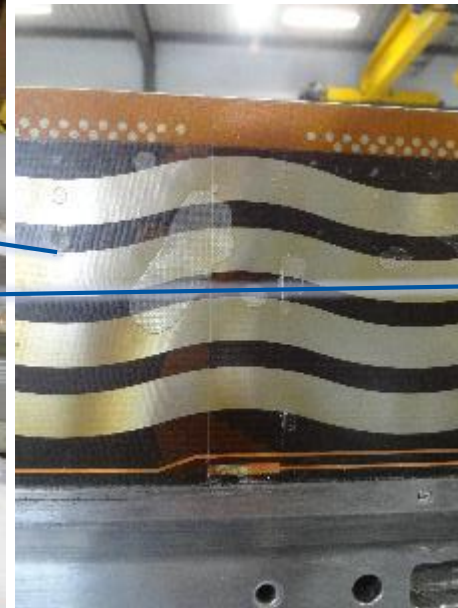
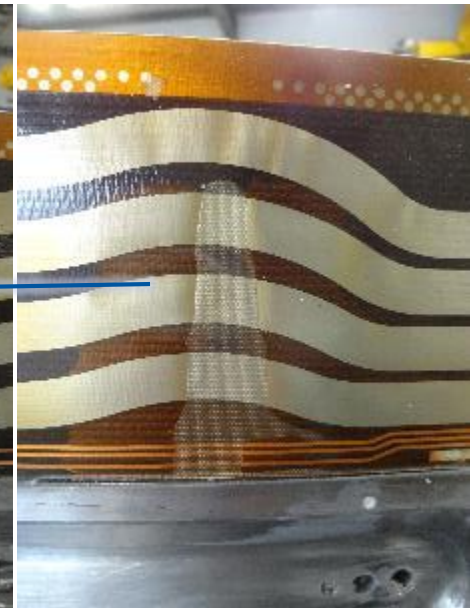
- Continuity measurement
  - Reflectometry
  - 4-point measurement
- **Tests stopped**
- **3401 will be replaced**
- } Turn 22, 70 % of coil from upper splice  
→ Corresponding to the location of a 'bubble'  
→ **Risk of a turn-to-turn short**

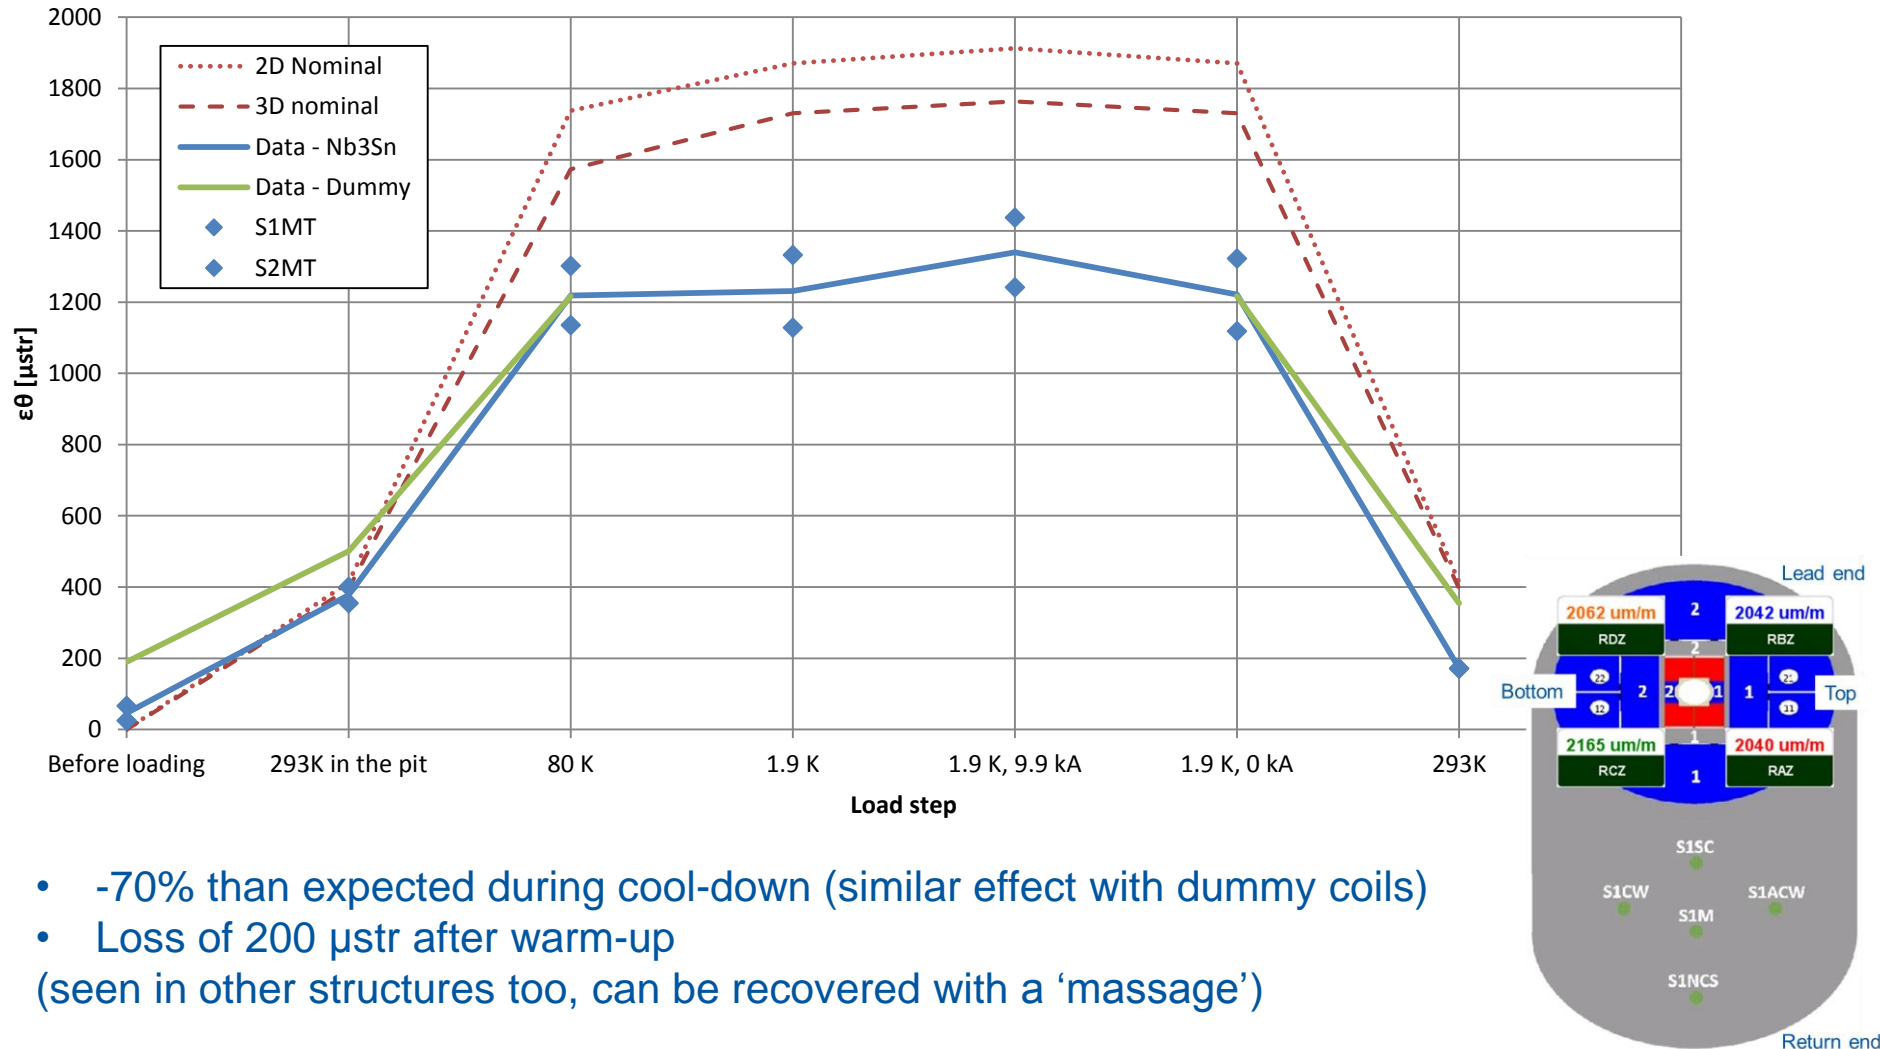
- -70% than expected during cool-down (similar effect with dummy coils)
- Loss of 200  $\mu\text{str}$  after warm-up  
(seen in other structures too, can be recovered with a 'massage')

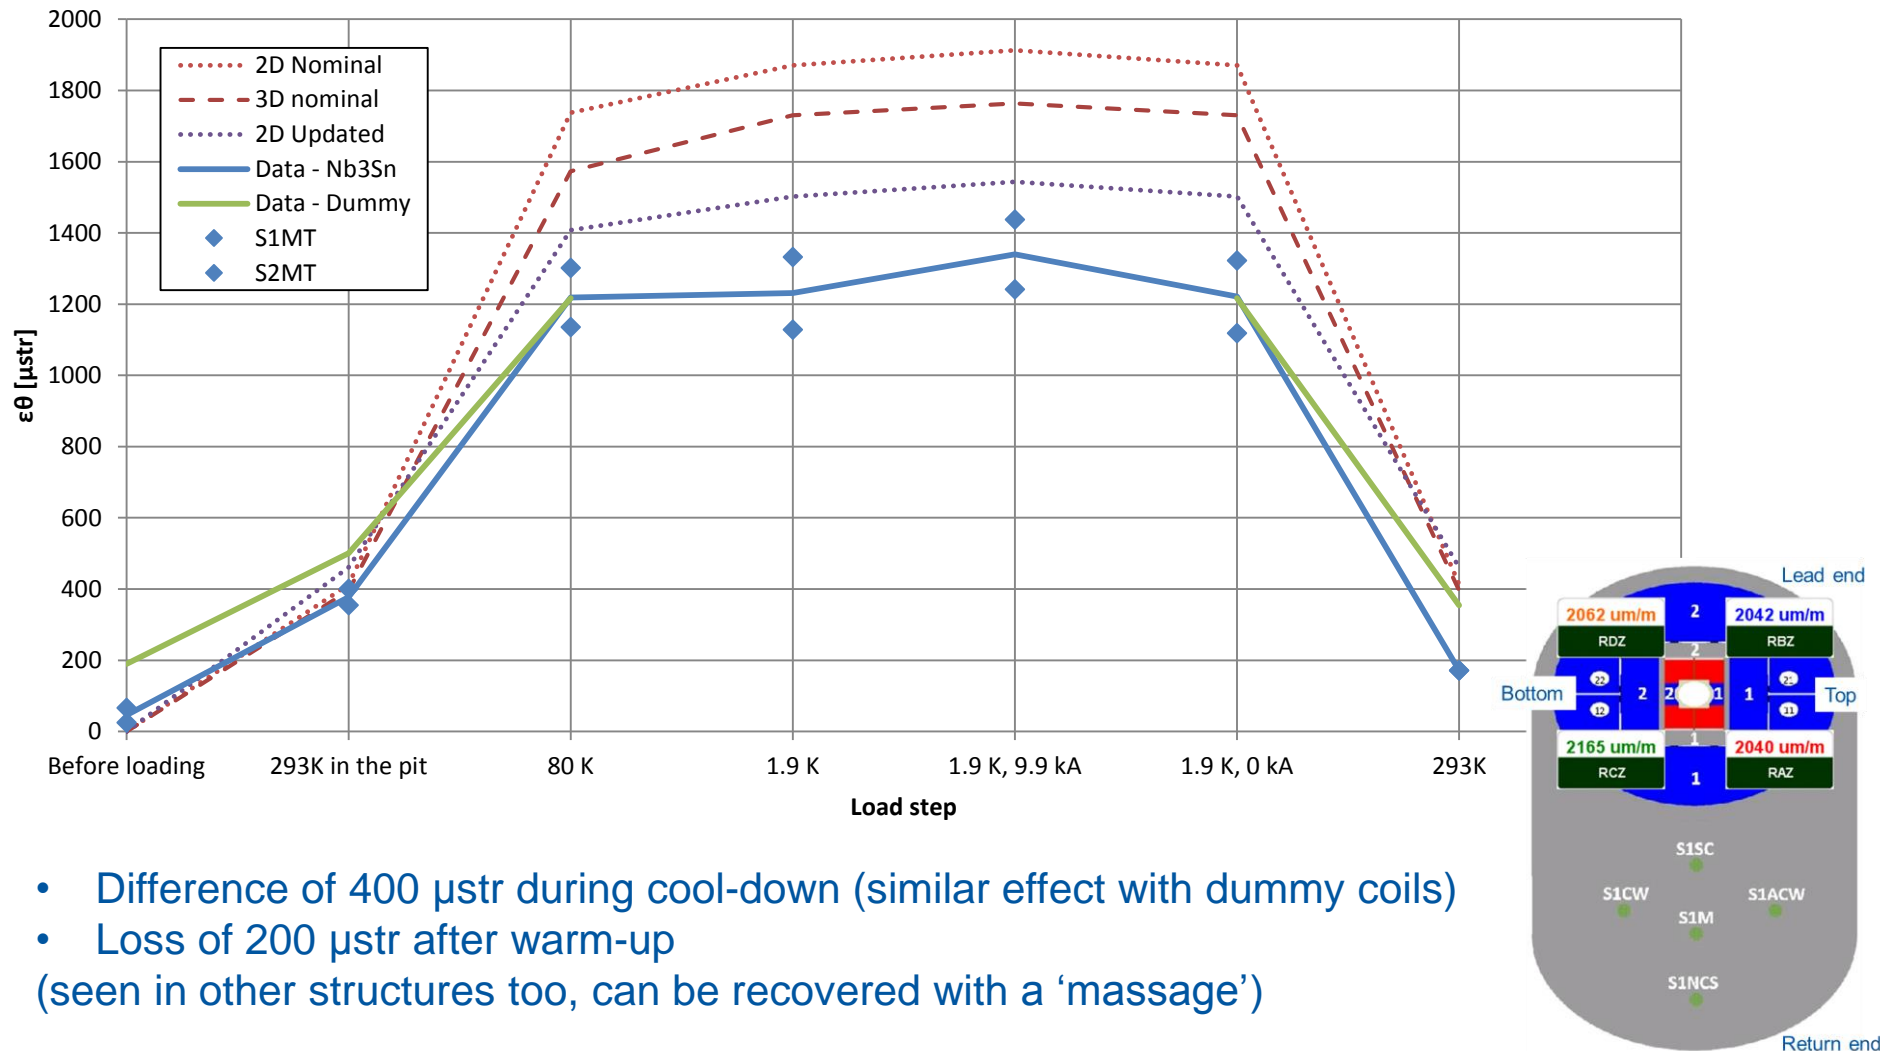
- Difference of 400  $\mu\text{str}$  during cool-down (similar effect with dummy coils)
- Loss of 200  $\mu\text{str}$  after warm-up (seen in other structures too, can be recovered with a 'massage')

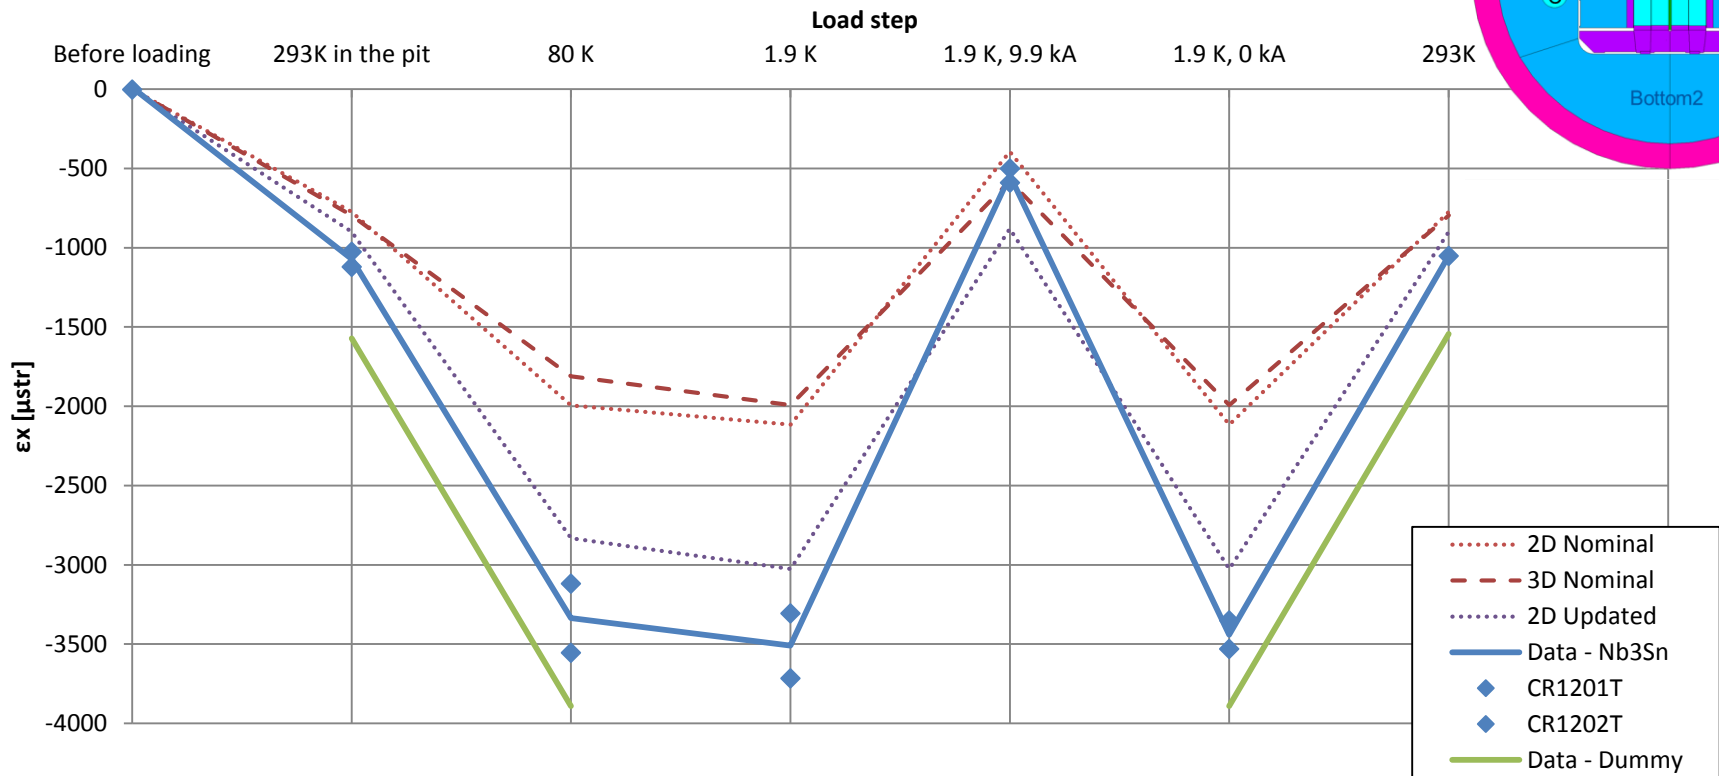
- Difference of 1500  $\mu\text{str}$  during cool-down (similar effect with dummy coils)
- No loss after warm-up

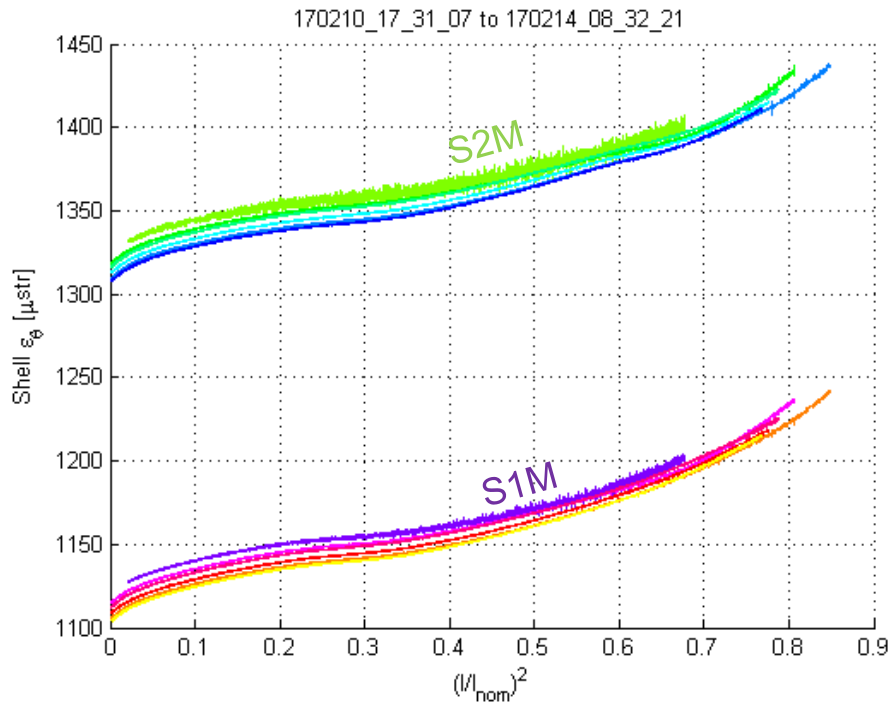
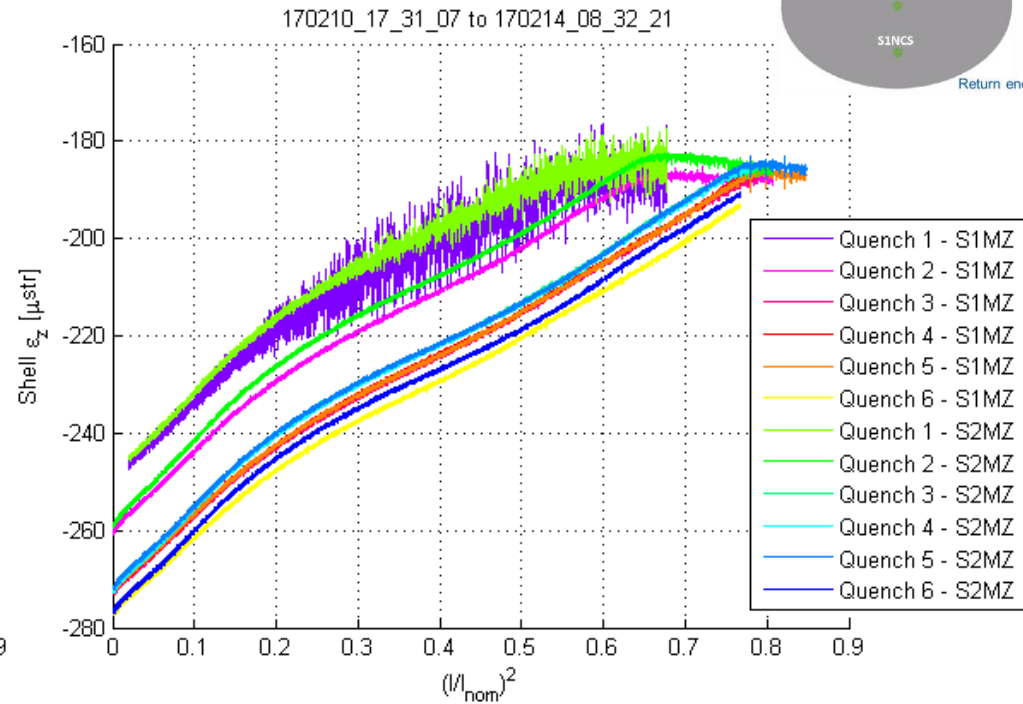
- Linear unloading with  $I^2$
- Difference left/right of 200  $\mu\text{str}$  (15%)

- Saturation at about -180  $\mu\text{str}$
- Loss of contact?
- Cycling effect (+30  $\mu\text{str}$  after 6 quenches)

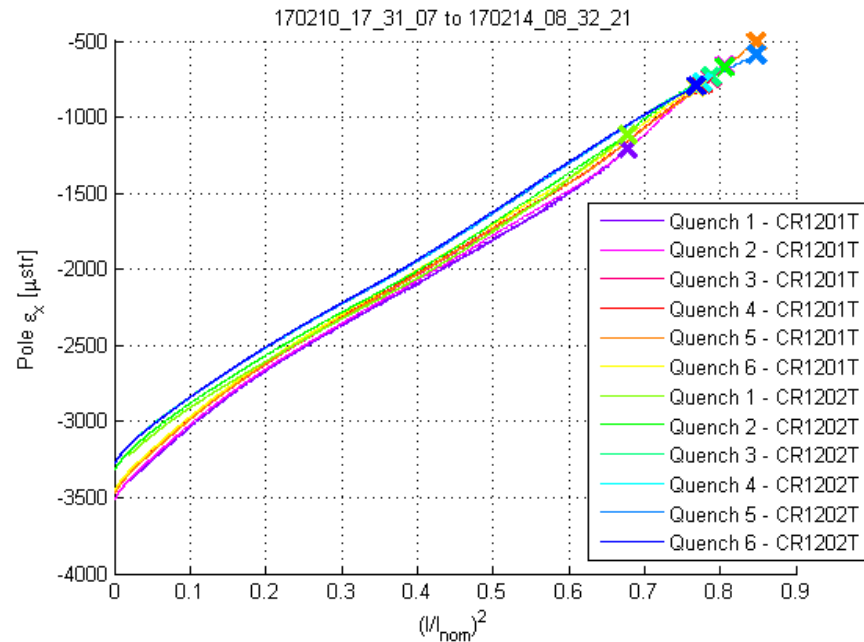
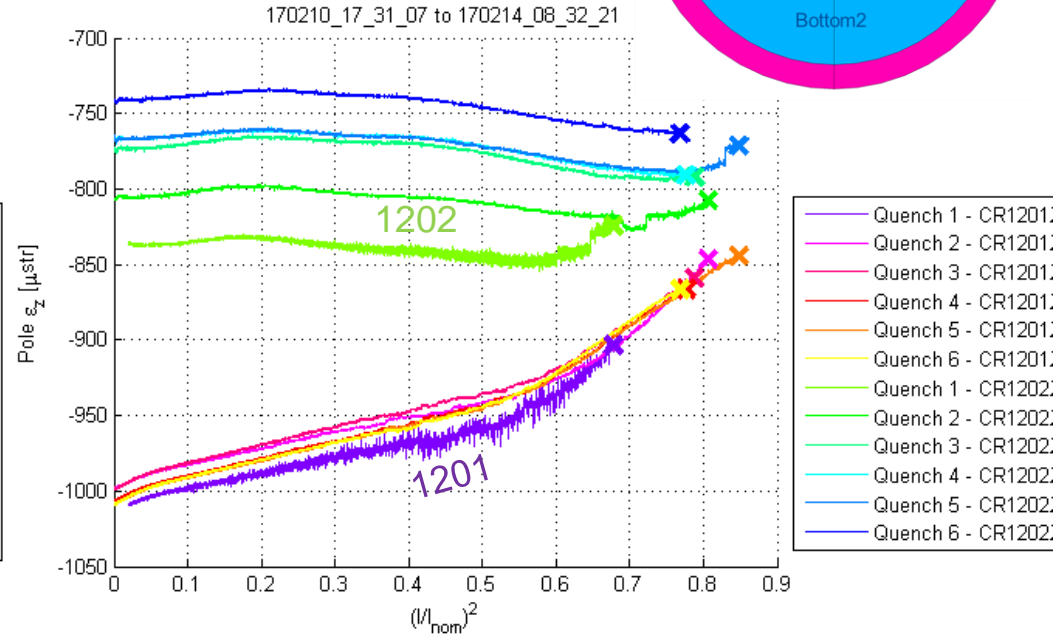
- Linear unloading with  $I^2$
- No cycling
- Balanced left/right

- Load on 1202 constant with current (as predicted by the model)
- Cycling (100  $\mu\text{str}$ )
- 1201 unloading
- Bending due to deformed pole?

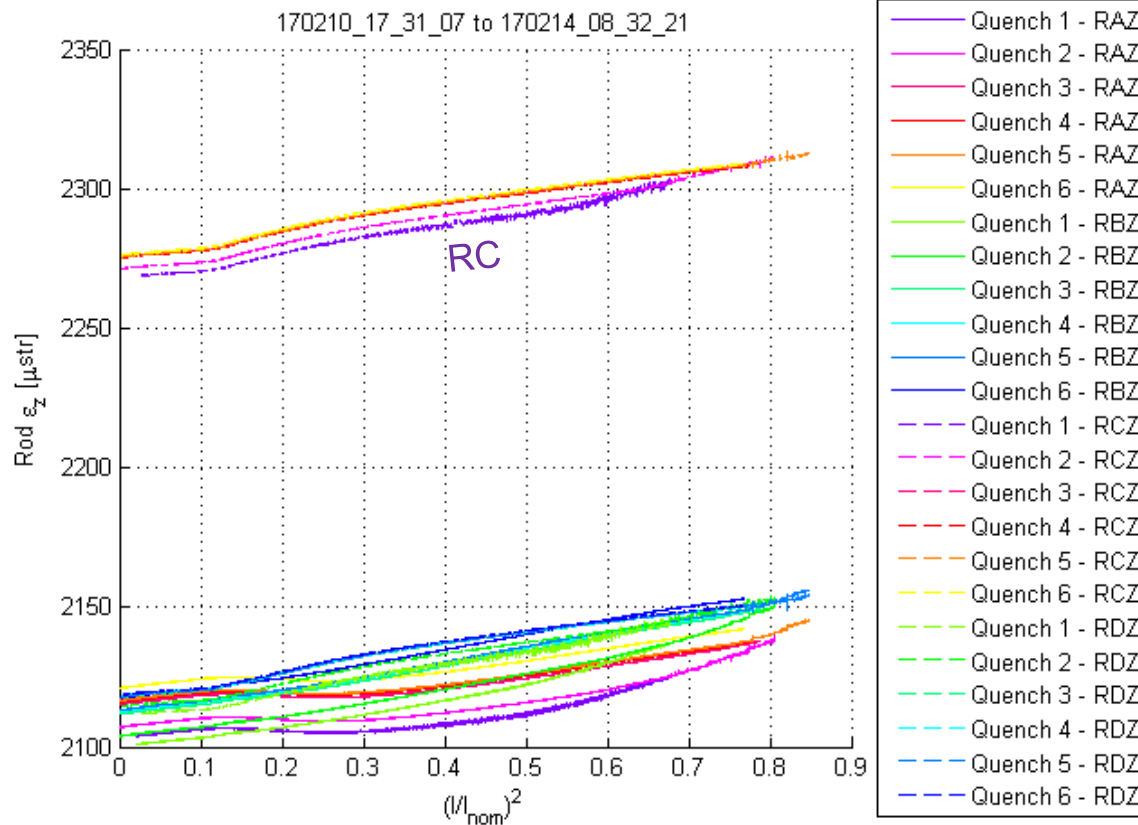
- Slight increase with  $I^2$  (predicted by the model)
- Negligible cycling (10  $\mu\text{str}$ )
- Rod C unbalanced (+170  $\mu\text{str}$ ) due to absence of counter-bolt

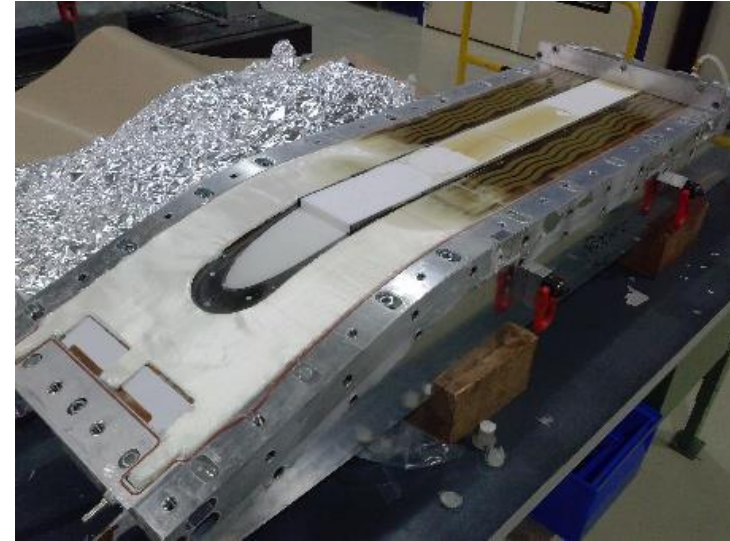
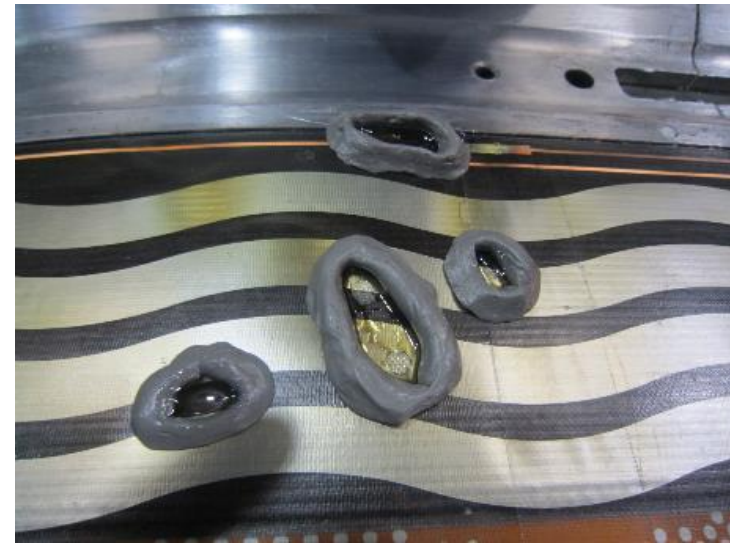
- Coils CR1201 and CP3403: **the resin did not go through**
  - CR1201: premature polymerization
  - CP3403: insufficient injection
  - **New injection holes** in the mould for 2<sup>nd</sup> impregnation

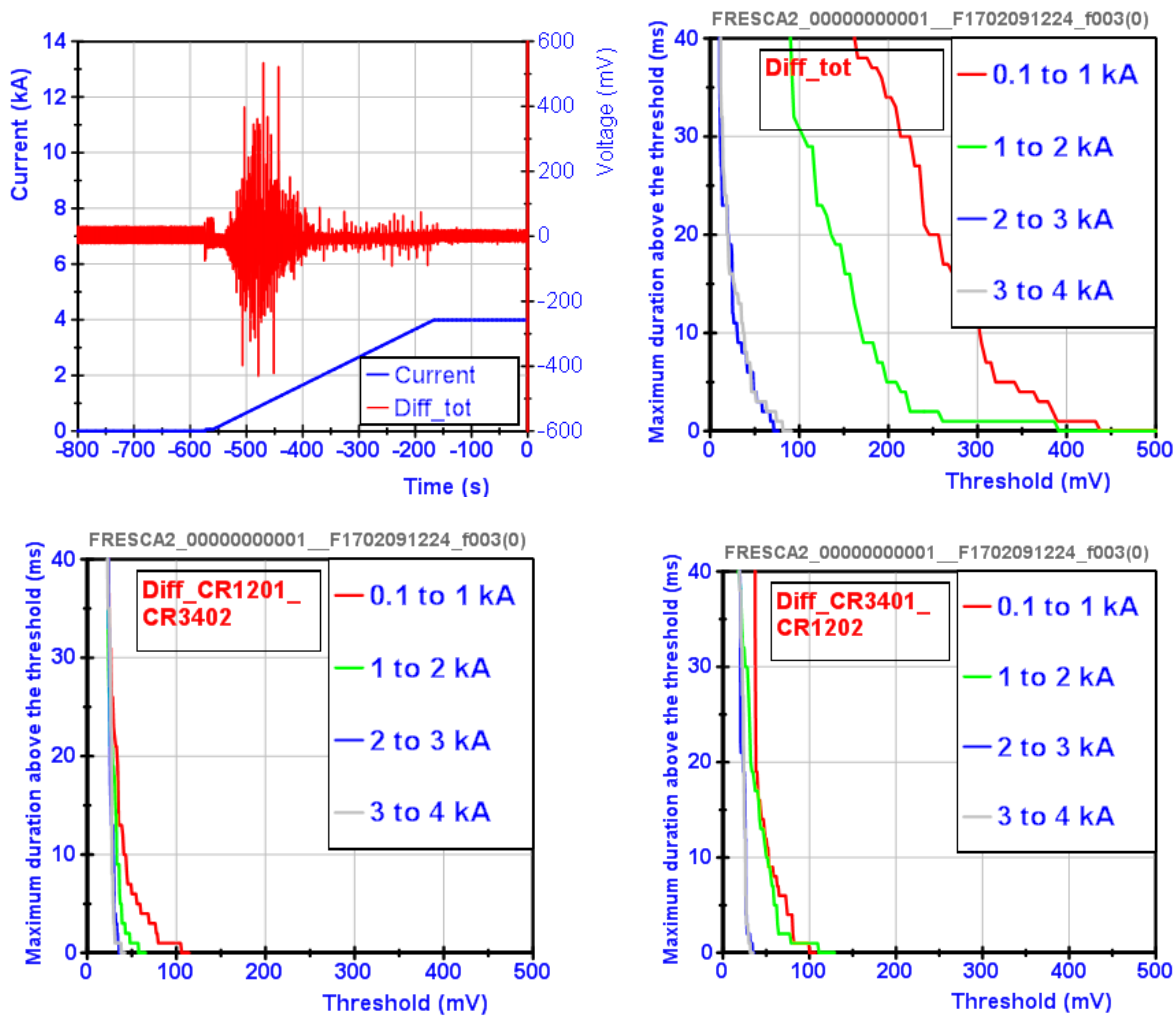
Flux jumps prevent setting the threshold

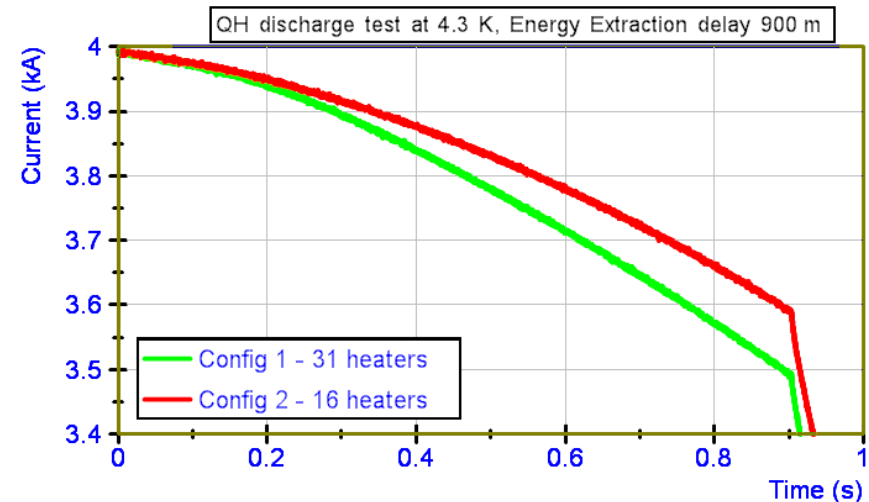
Due to limited number of 8 QH power supplies two configurations were tested at 4 kA, 4.3 K:

1. Using all 31 heater strips (same density, half the time constant, half the energy)
2. Using 16 heater strips

Configuration 2 gave already better results for low current: this was chosen for further testing.
