# Assembly and First Training of the Dipole Magnet FRESCA2

29/03/2017

E. Rochepault

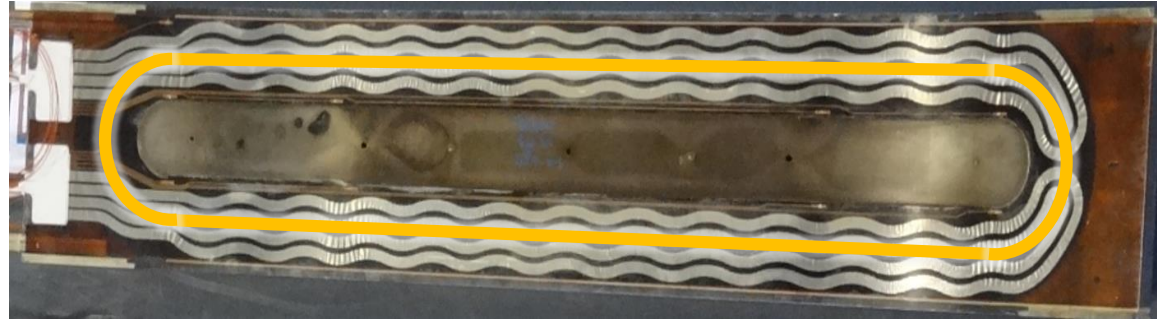
From continuity measurement at room temperature:  
Touching at turn 22 ± 1 (counting from splice)

From Transfer Function measurements at 4 K by Mateusz Bednarek, QH is touching the coil at about 70 % of in coil inductance, seen from upper splice.

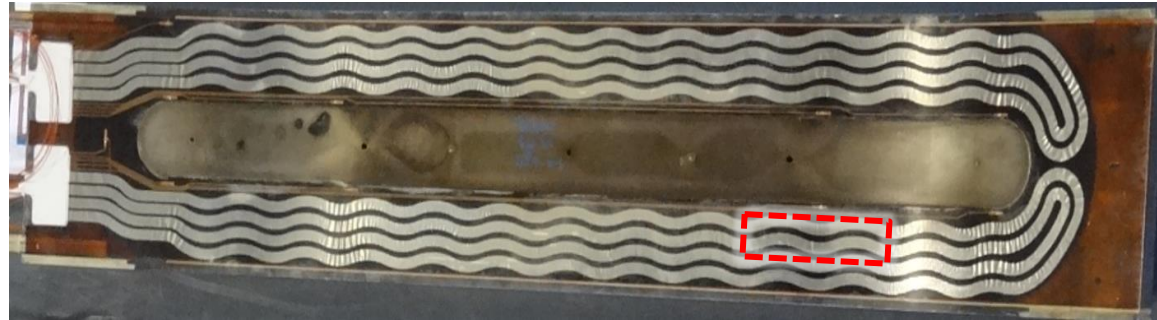
From 4 point measurements of the QH at 4 K, QH 3401LL1 is touching QH 3401LL2 at about 70 % of the strip length see from 3401LL1- or 3401LL2-

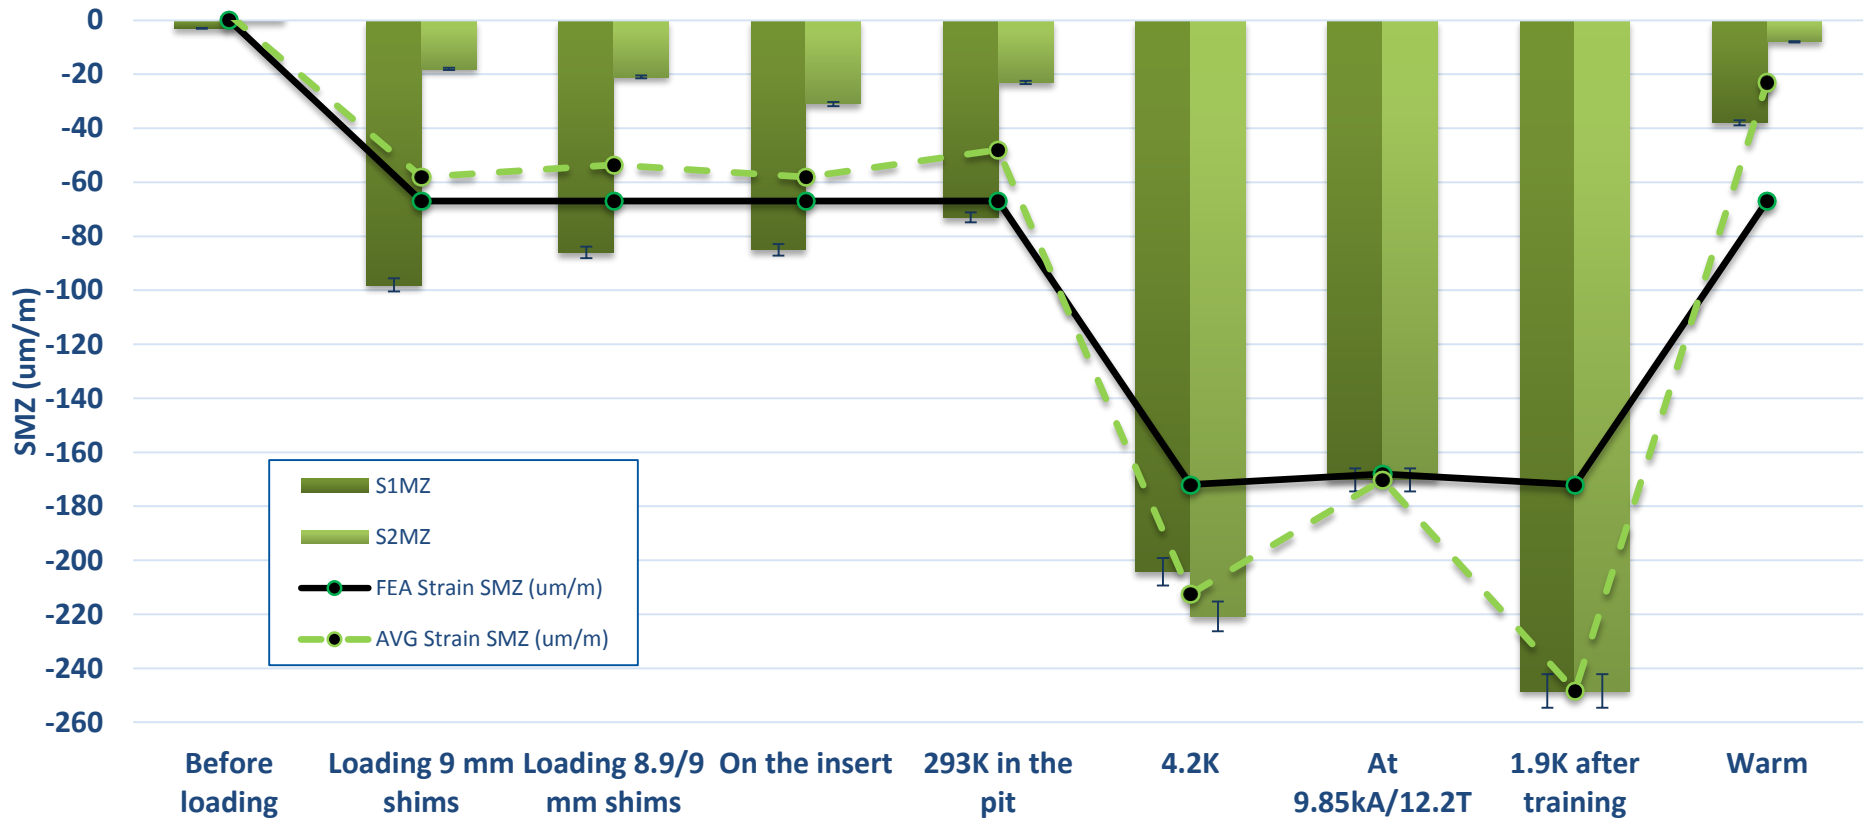
- Difference of 40  $\mu\text{str}$  during cool-down
- Loss of 25  $\mu\text{str}$  after warm-up
