# Fabrication, Tests and Assembly of the W7-X Magnets and Perspectives for the Technological Development of Fusion

C. Sborchia

Magnet Department, W7-X Team

Max-Planck-Institute for Plasma Physics (IPP), Euratom Association  
Branch Institute Greifswald (D)

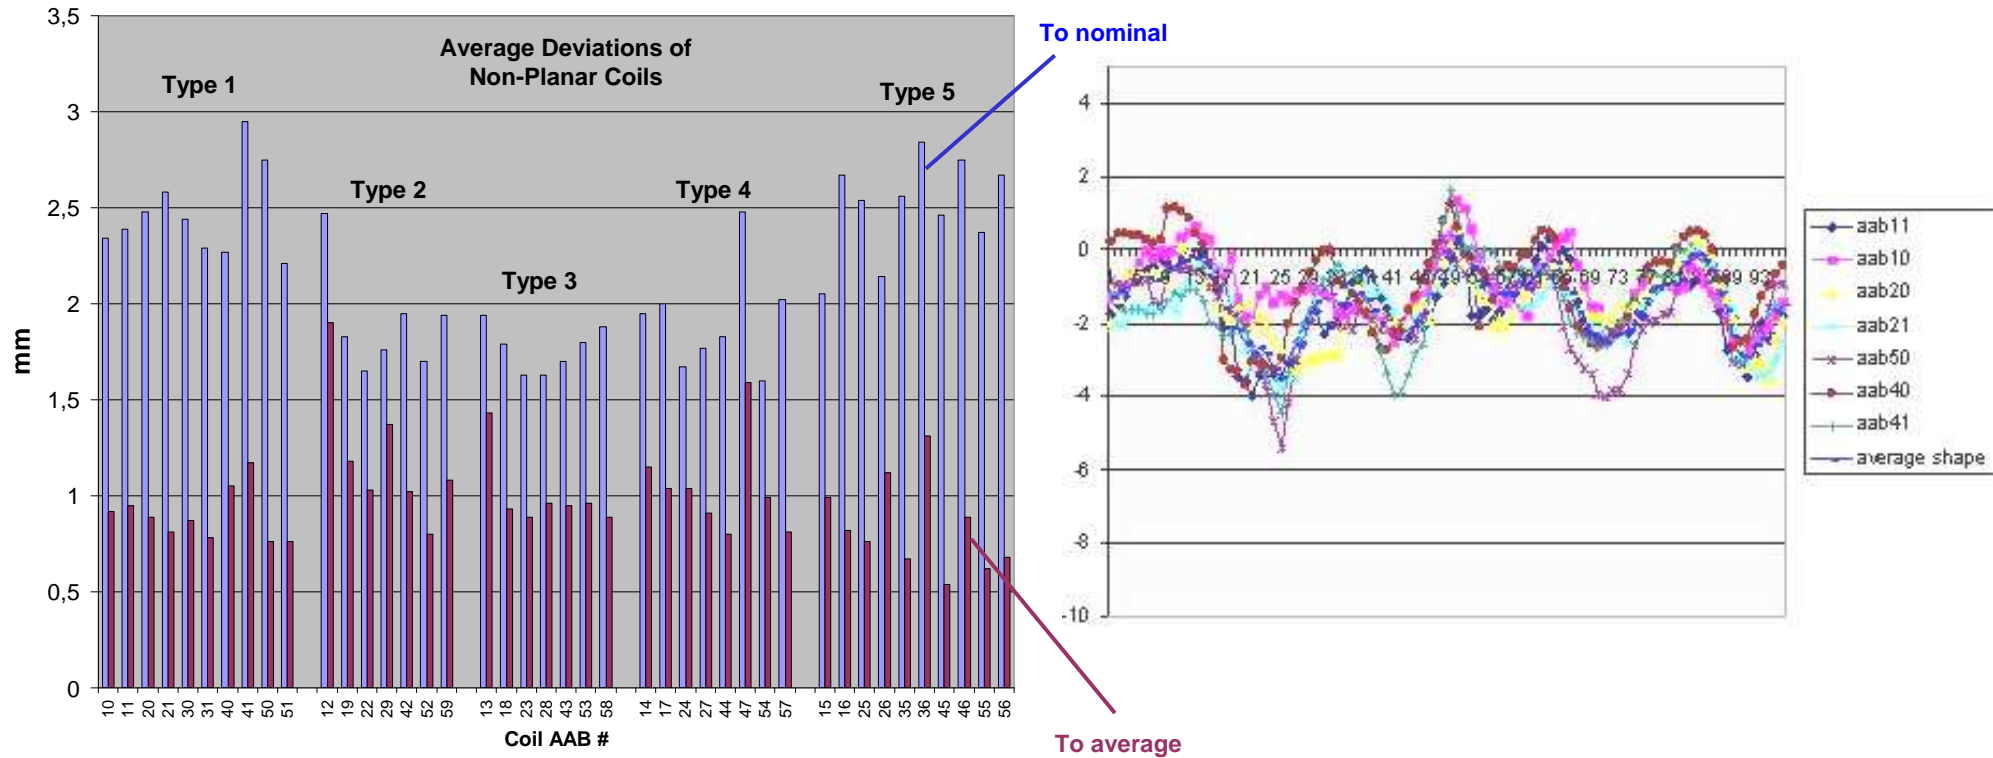
# Winding Accuracy

- The accuracy of the winding packages is measured on 96 longitudinal cross sections (8 points per section) with a laser tracker
- The average relative deviations are in the order of  $< 2$  mm

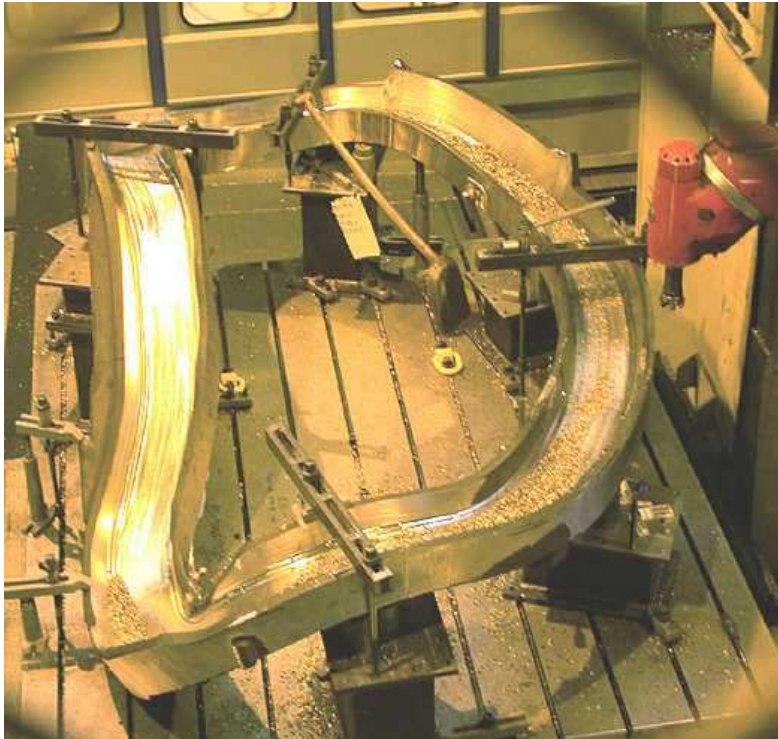
## Case Production

- cast process for single half shells and blocks
- heat treatment of half shells and blocks to achieve mechanical and physical properties
- pre-machining of half shells

*Case half shells produced by Österby Gjuteri AB in Sweden as subcontractor of BNN*

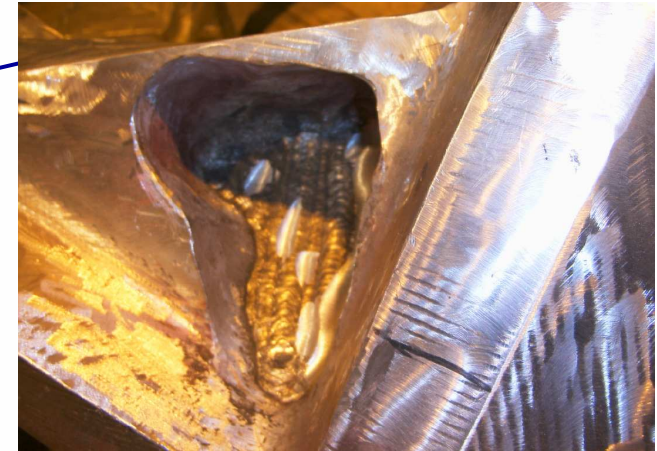
detection 2 (left)

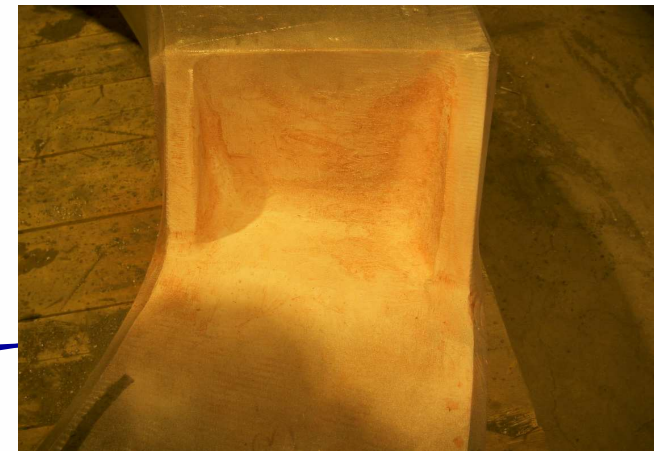
detections 3a and 3b (repaired)

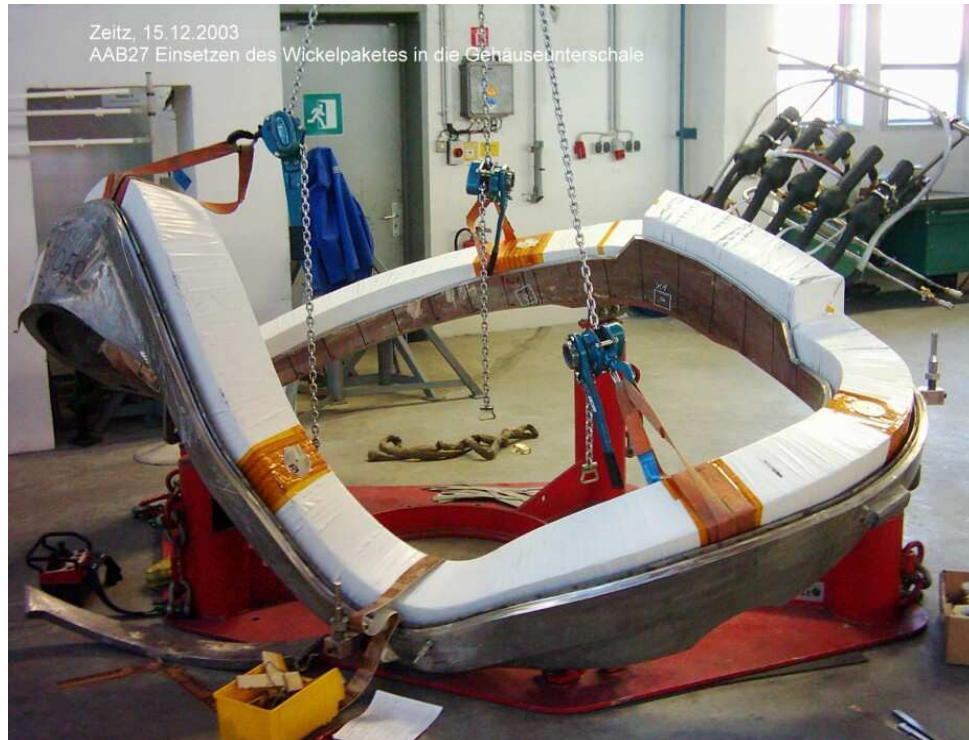
## Coil Assembly - Winding Pack Insertion

preparation of half shells with:

- assembly of protection steel plates around closure welds
- assembly of pipes inside for as resin distribution system
- assembly of handling and helping tools

inserting of winding pack into the base shell

placement of the lid onto the assembly

start with the root of the closure weld (WIG)

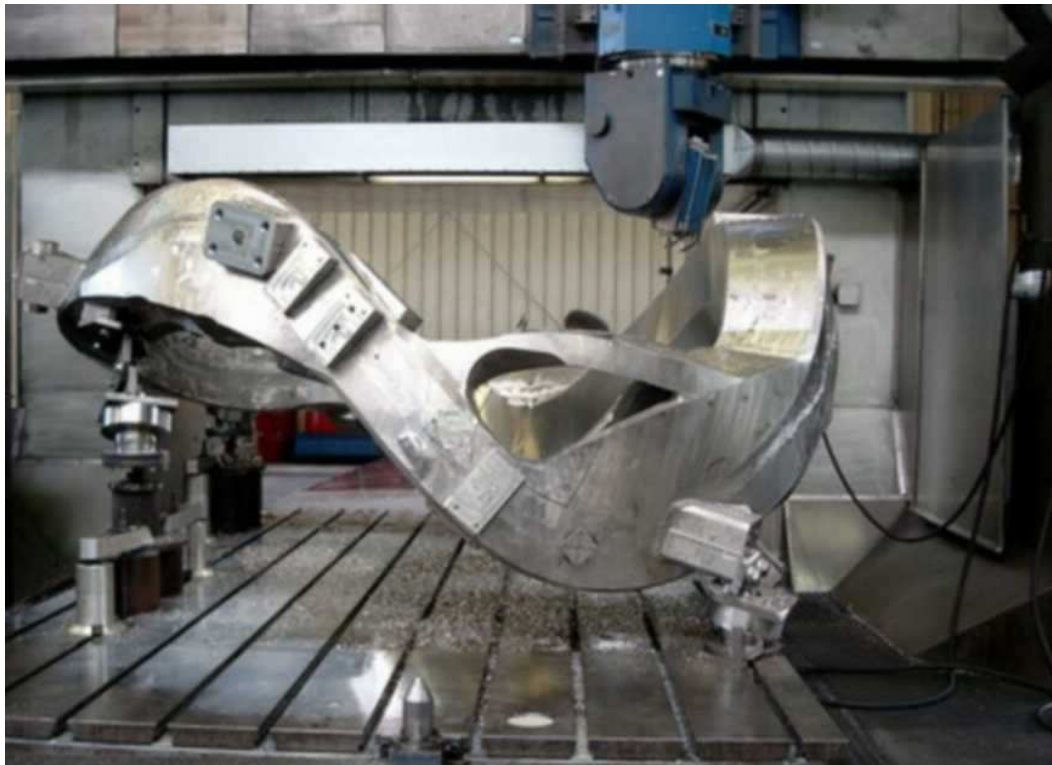
## Coil Assembly - Block Welding and Machining

### Block welding:

e.g. central support blocks, assembly blocks, weight support blocks were placed after embedding

### Machining:

of coil surface  
of machined faces on blocks  
of threads and fit holes

allowed tolerances  
for machined faces, threads and fit holes  
between 0.2mm - 0.6mm

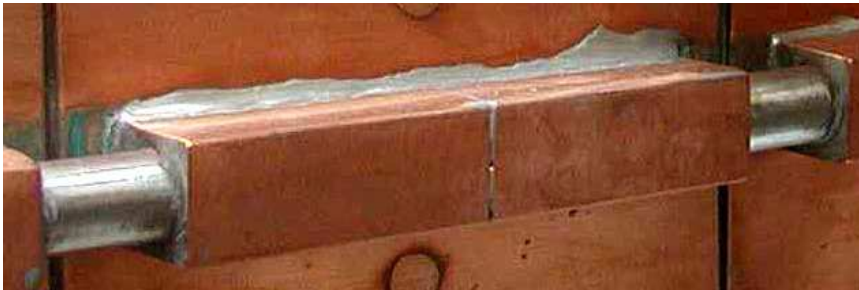
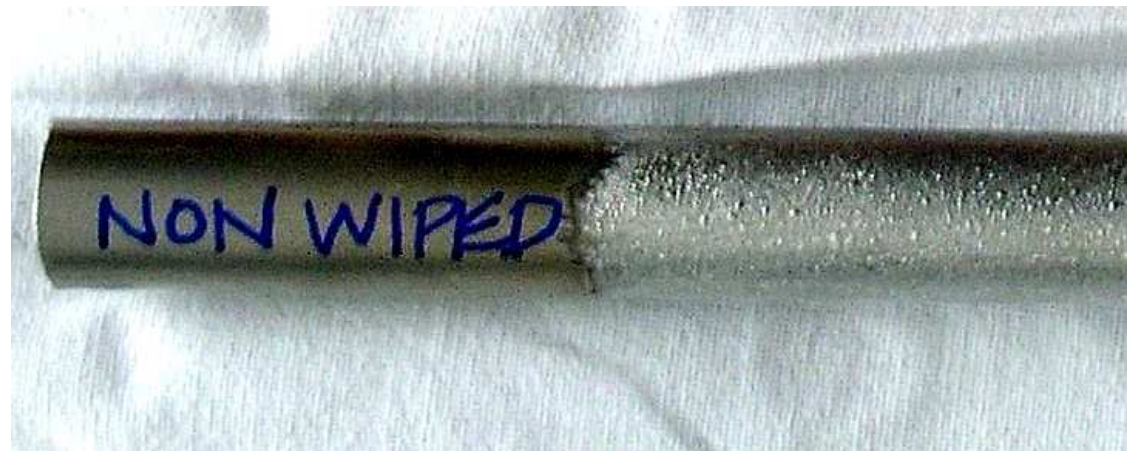
## Cracks in cooling pipes

- Cracks in cooling pipe of coil AAC 52 due to residuals of chlorides
  - Removal of all cooling pipes
  - Use of new pipes (larger wall thickness)
  - Pre-tinning of cooling pipes and cleaning
- 
- Minor change of cooling tube carriers (two additional holes for a better supply of the filler material)
  - Soldering pipes into blocks using non-aggressive flux and solder filler P60/40 (lead/tin)
  - Soldering blocks onto copper cladding using soldering shim and non-aggressive flux
  - Leaks test of cooling pipes before mounting
  - Work specimen during production

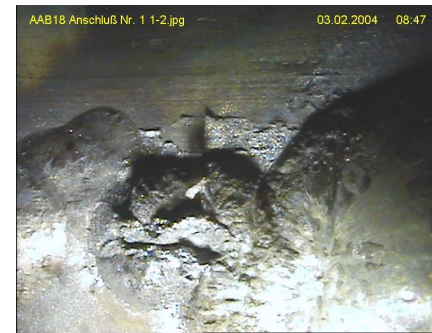
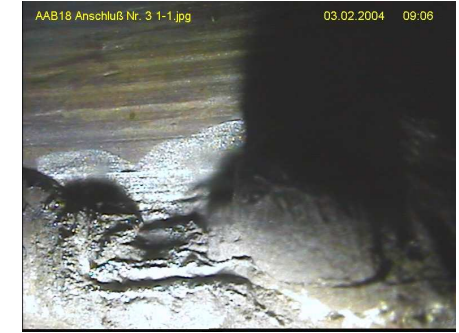
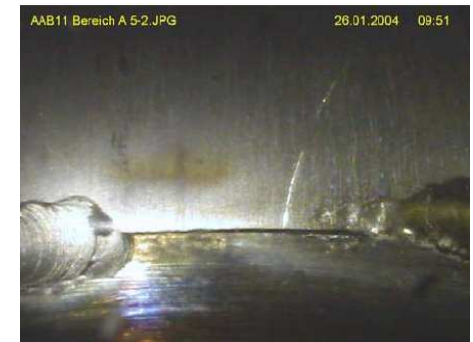
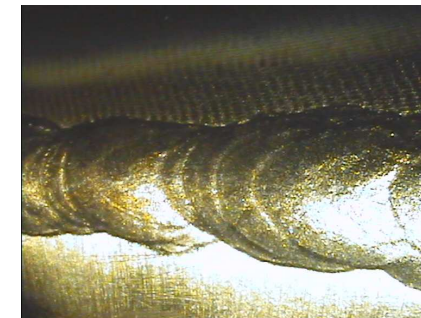
## Repair of Headers and Filters

- Welding defects found at He-Inlets/ Outlets SS and Al welds on both NPC and PC.
- Rework is in progress.

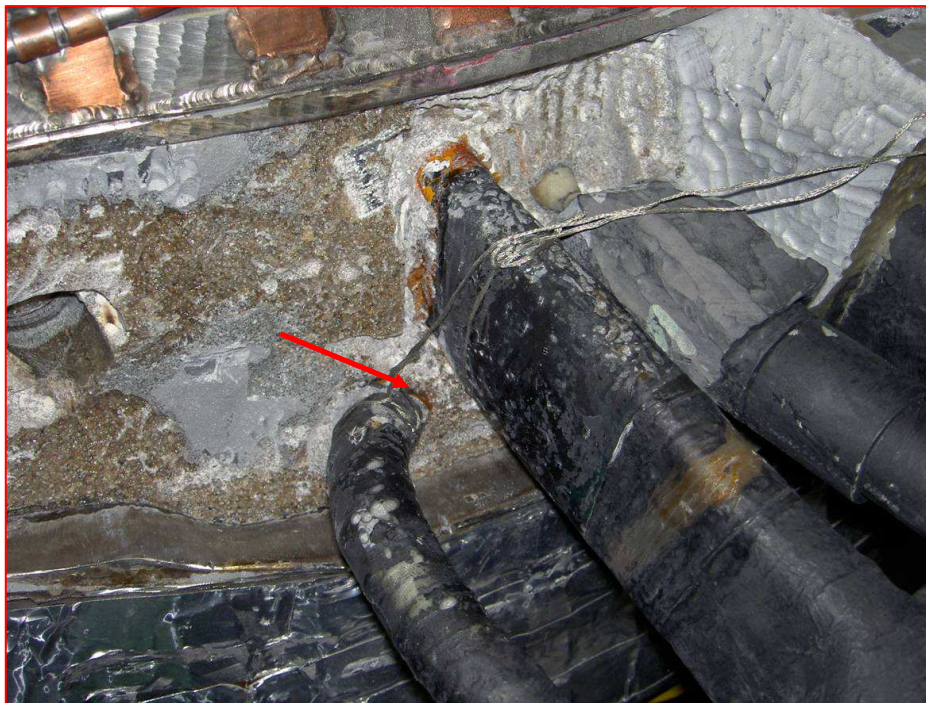
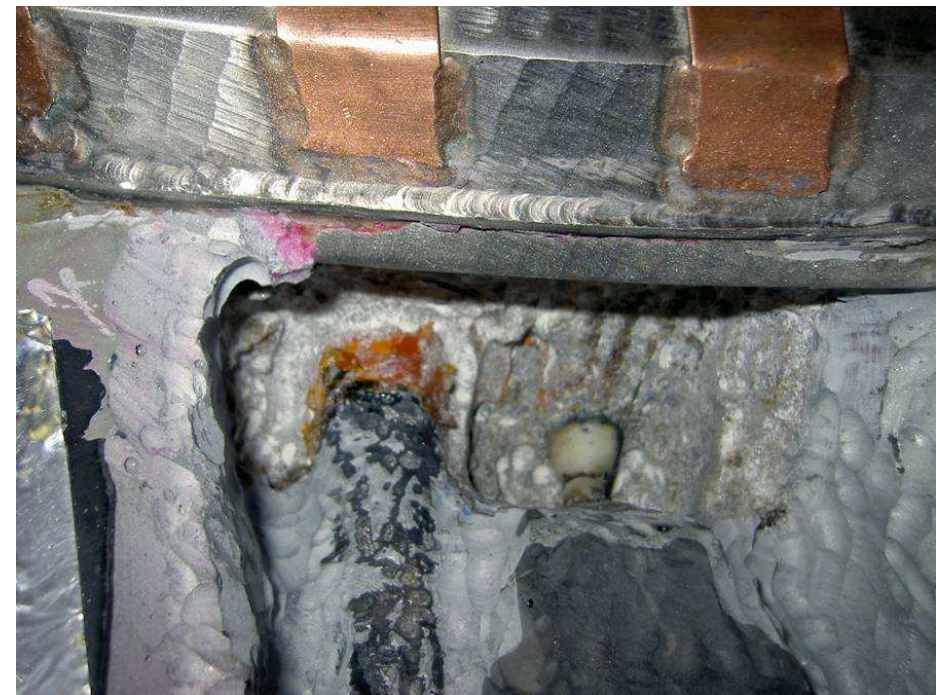
## AAB25

- The whole coil termination area has been excavated
- Holes and cavities have been filled with charged epoxy and all penetrations reinforced with glass tapes
- New cold testing foreseen in Saclay in May 2006

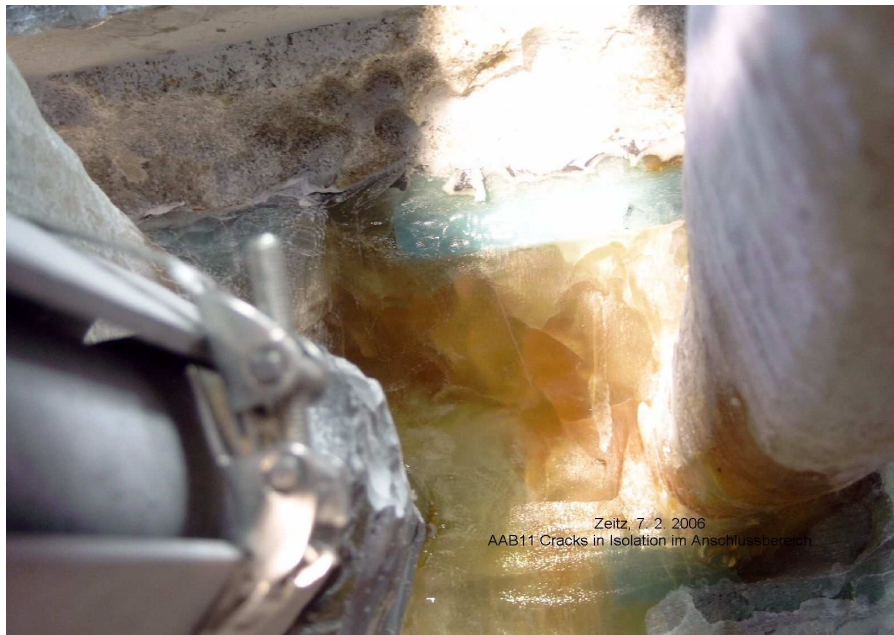
## AAB11

- The coil does not present holes and cavities
- The gaps between G-11 plates (in green) have been filled with pure epoxy resin during vacuum pressure impregnation
- The pure resin has cracked down during cooldown at Saclay
